## Inspection Report Minerals Regulatory Program Report Date: November 17, 2004

**Mine Name:** Last Chance Clay Mine

**Permit number:** M/015/061

**Inspection Date:** November 5, 2004

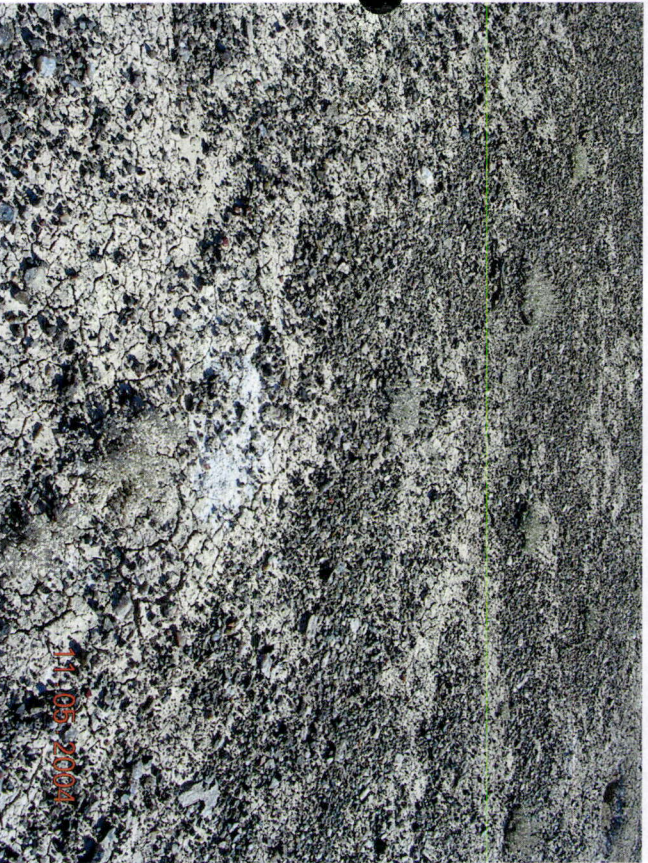
Photos 1 and 2 show vegetation on clay soils in areas adjacent to the mine. There is obviously not a lot growing in these areas, but there are a few plants, particularly in and next to the rills. When the site is reclaimed, it will be important to leave features that can collect water.

**Photo 1. Vegetation in an area near the pit.**

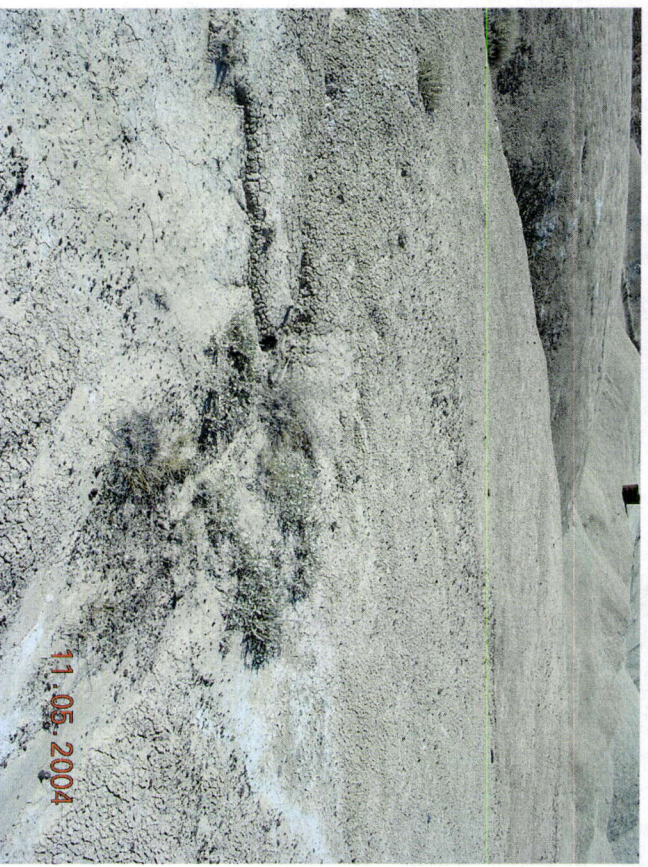
**Photo 2. Another undisturbed area near the pit. Note that the vegetation is concentrated in a low place next to the rill.**

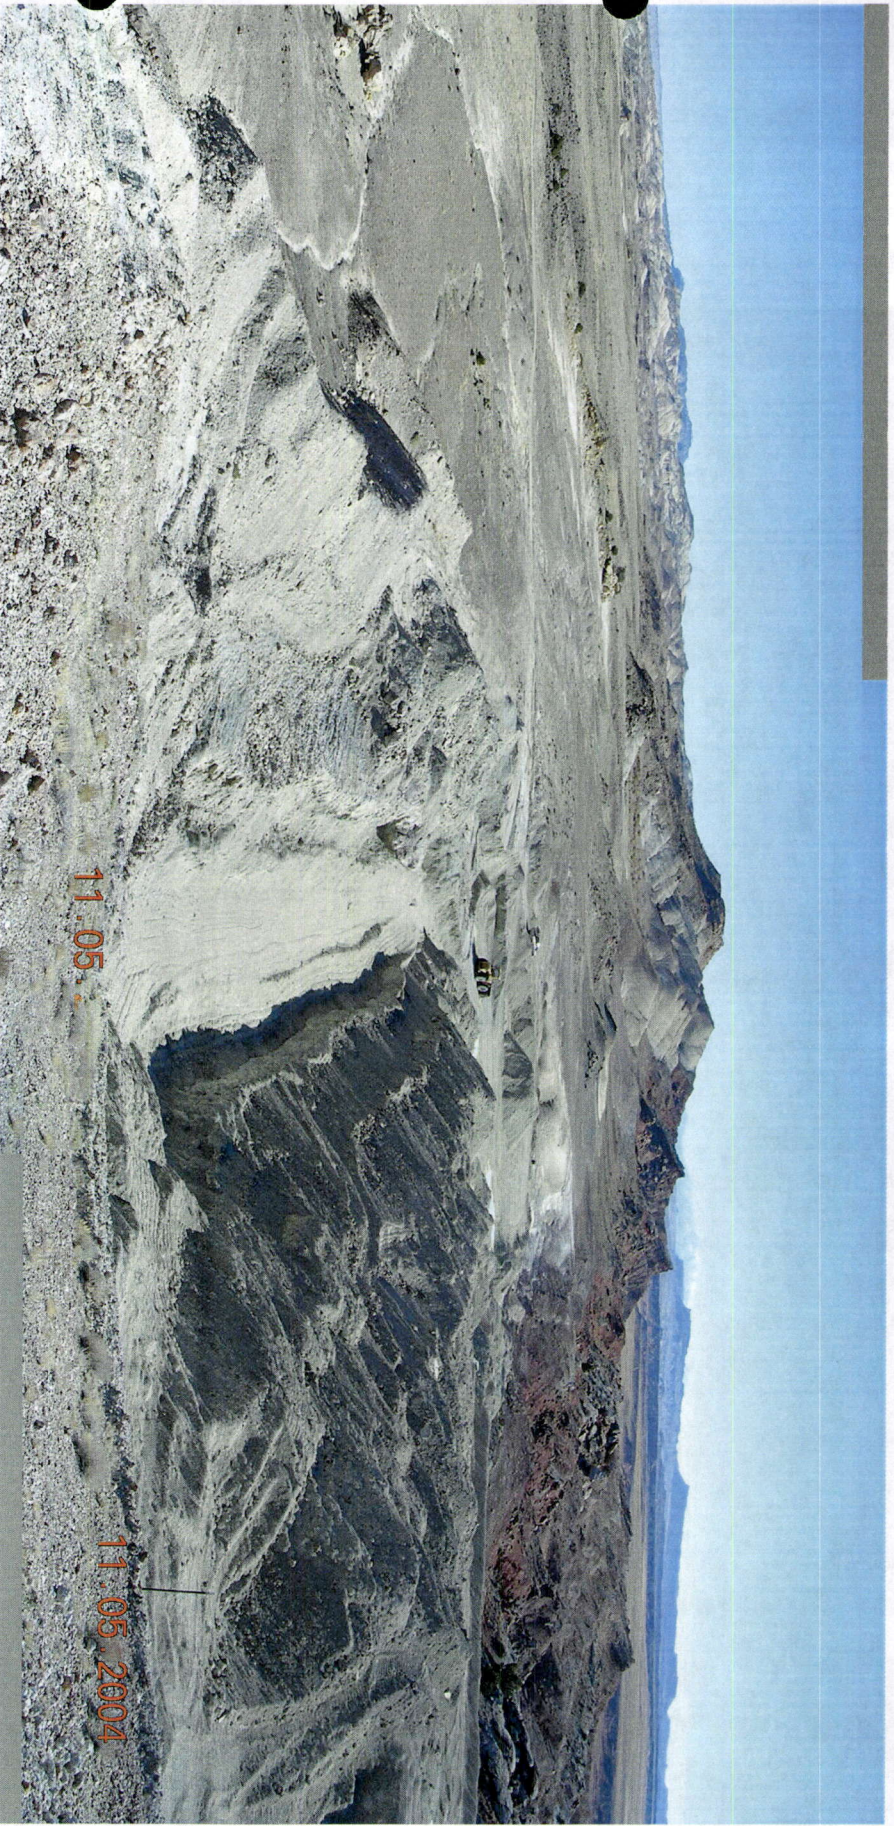
The site has not changed much since the last inspection in February 2003. I did not take photos during that inspection, so I do not have a photo record to compare with the current conditions. I believe there may have been some mining toward the northeast, but it has not been substantial. The site is shown in Photos 3 and 4.

**Photo 3. Composite of two photos showing the mine pit.**

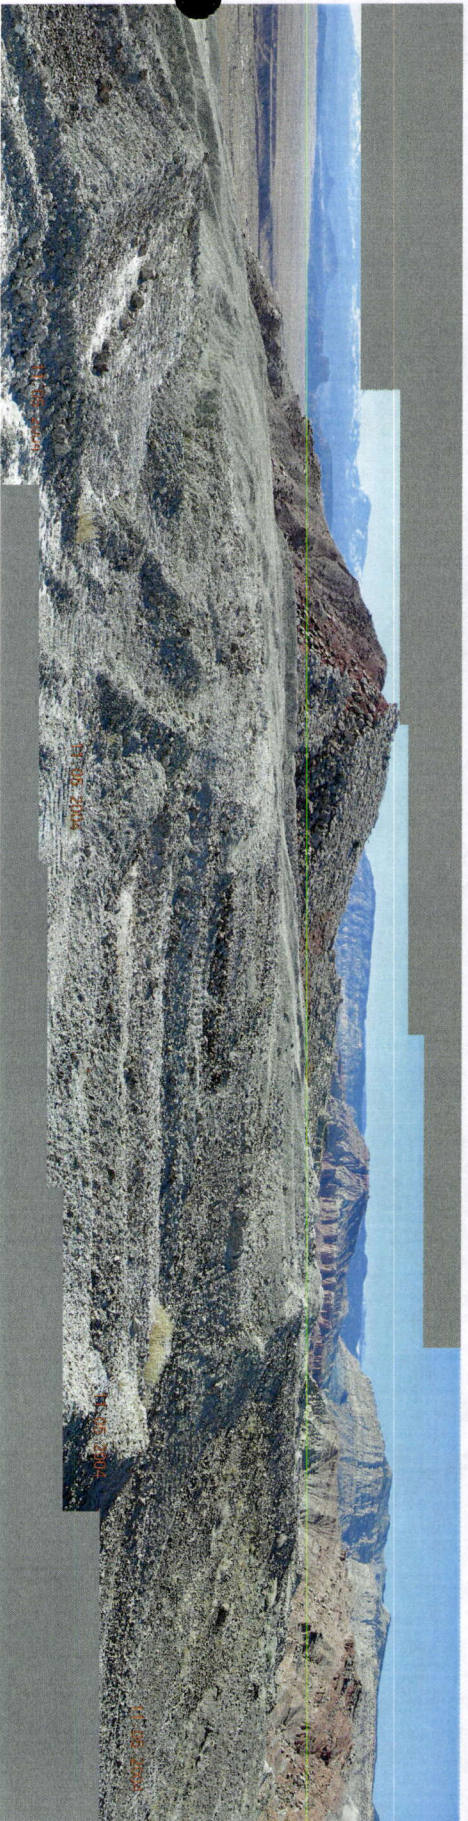
Photo 4. Disturbance north of the pit. This is a composite of five photos, and there is some distortion.

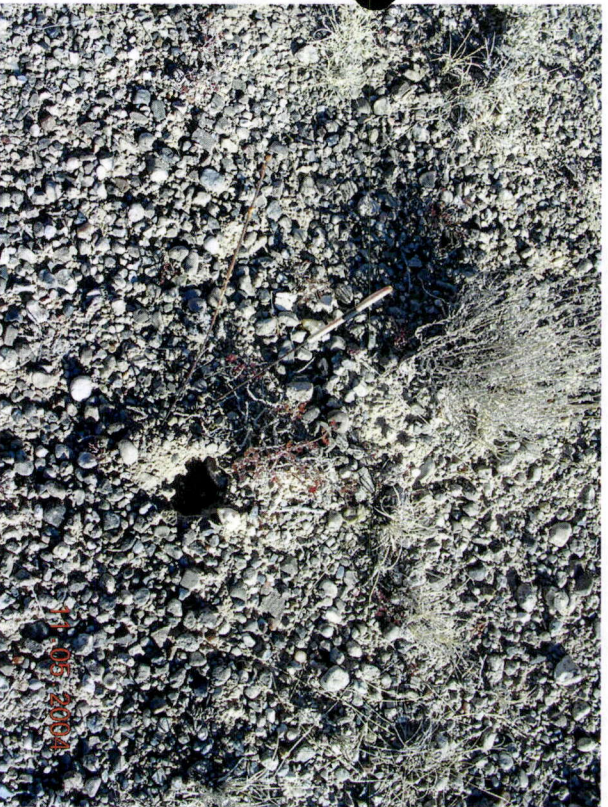
There is a population of Winkler's footcactus north of the mine. This is a listed threatened species. Several plants were flagged a few years ago, and I found plants at most of these flags. At one location (Photo 5), there was a small hole and no plant. It appears the cactus may have been dug up. I have informed a biologist with the Bureau of Land Management of the missing plant.

Photo 5. The deteriorated flags indicate there was an individual of *Pediocactus winkleri* here, but it appears the plant may have been dug up.
